THERMANN CASE STUDY – Crowne Plaza Terrigal Pacific

- STATE New South Wales
- LOCATION Terrigal
- BUSINESS Hotel

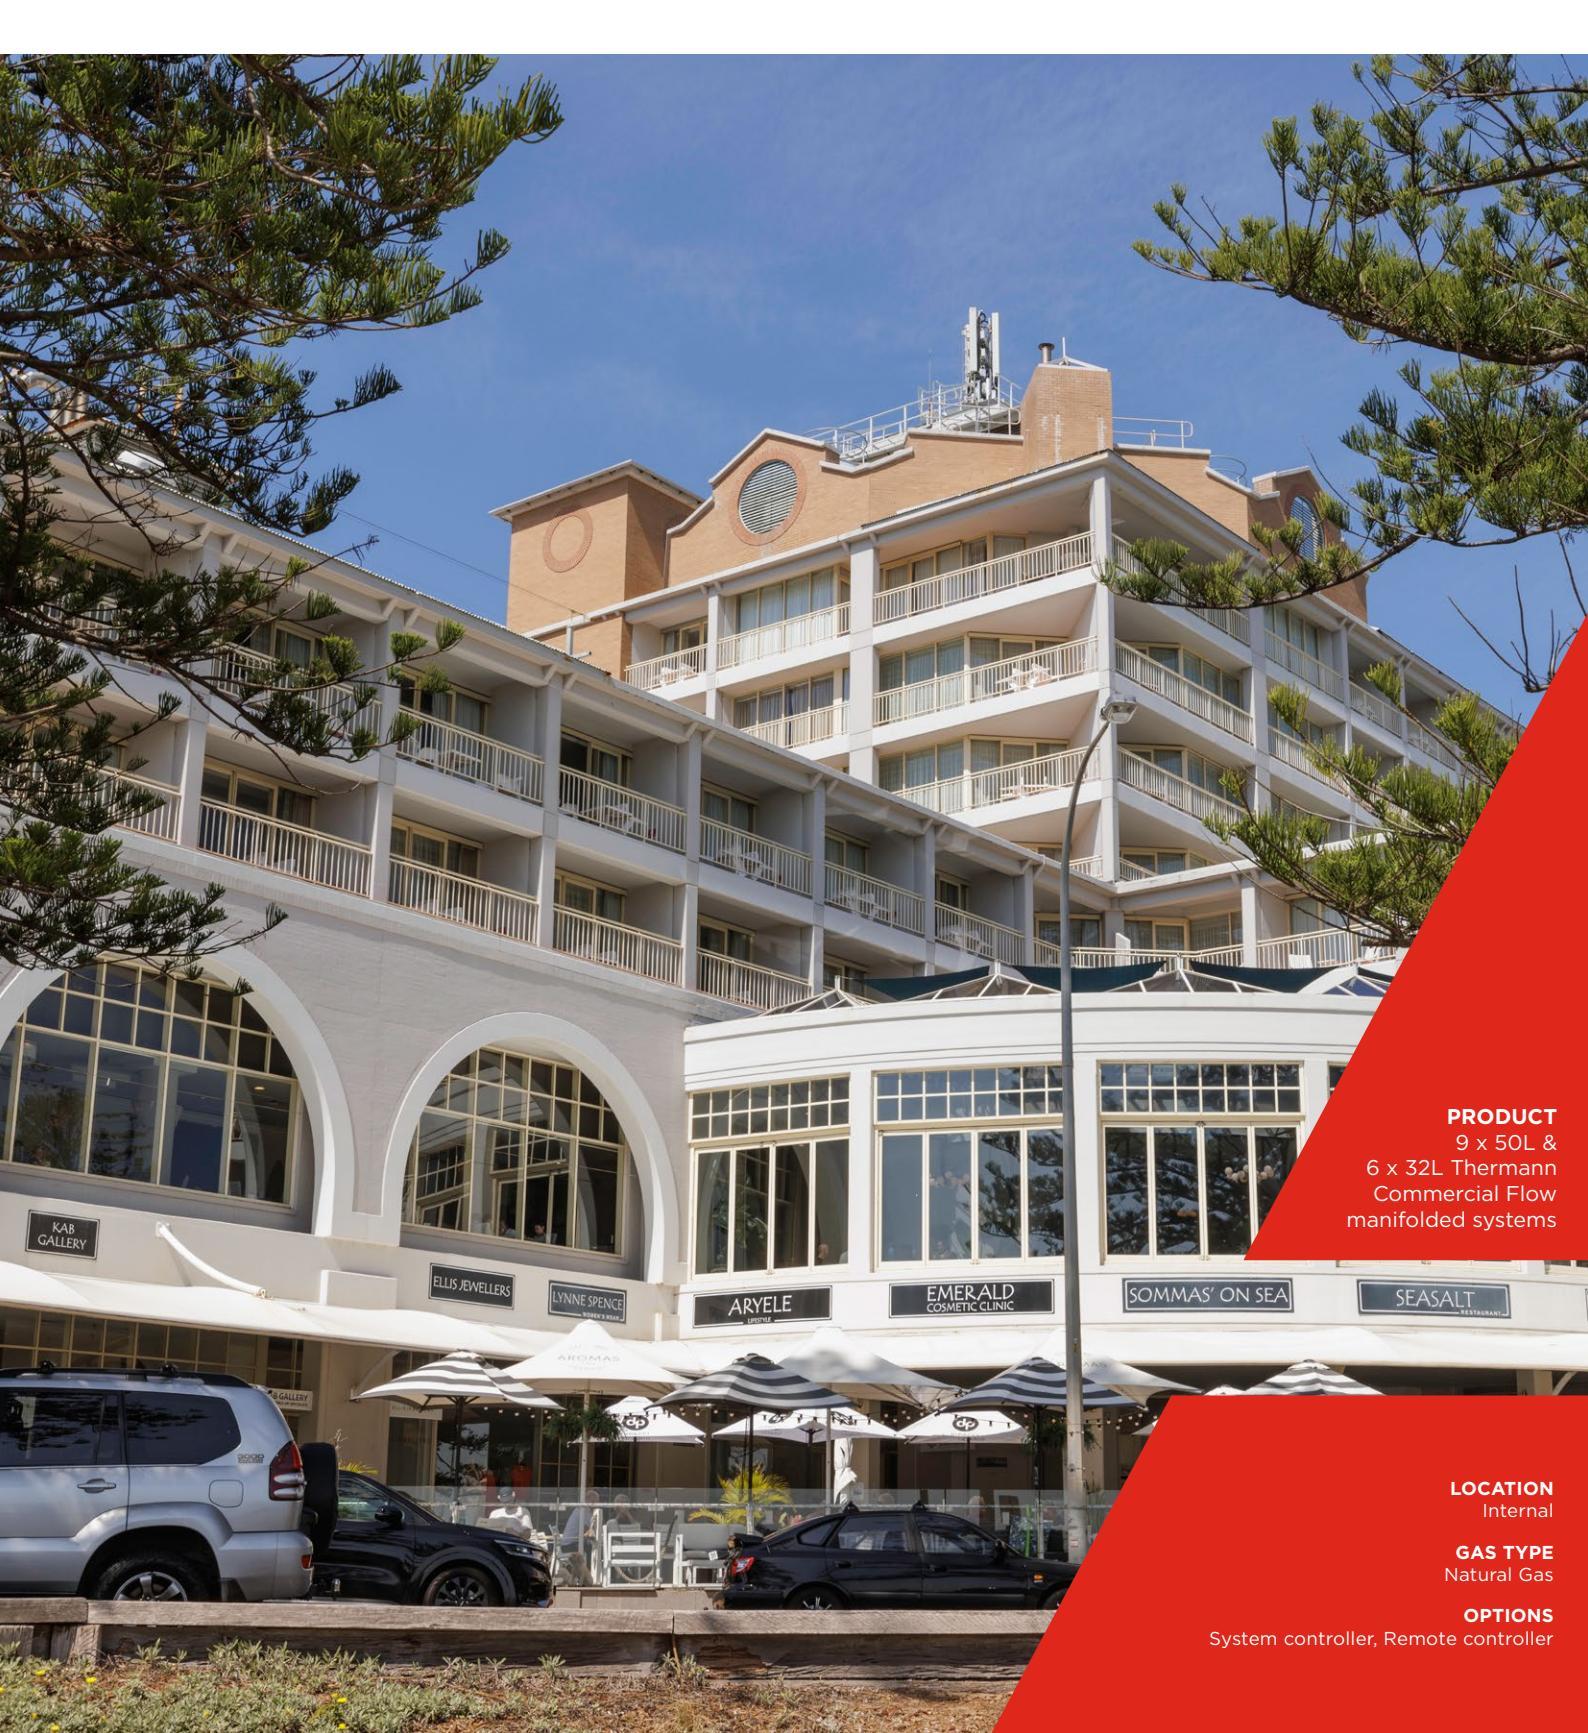
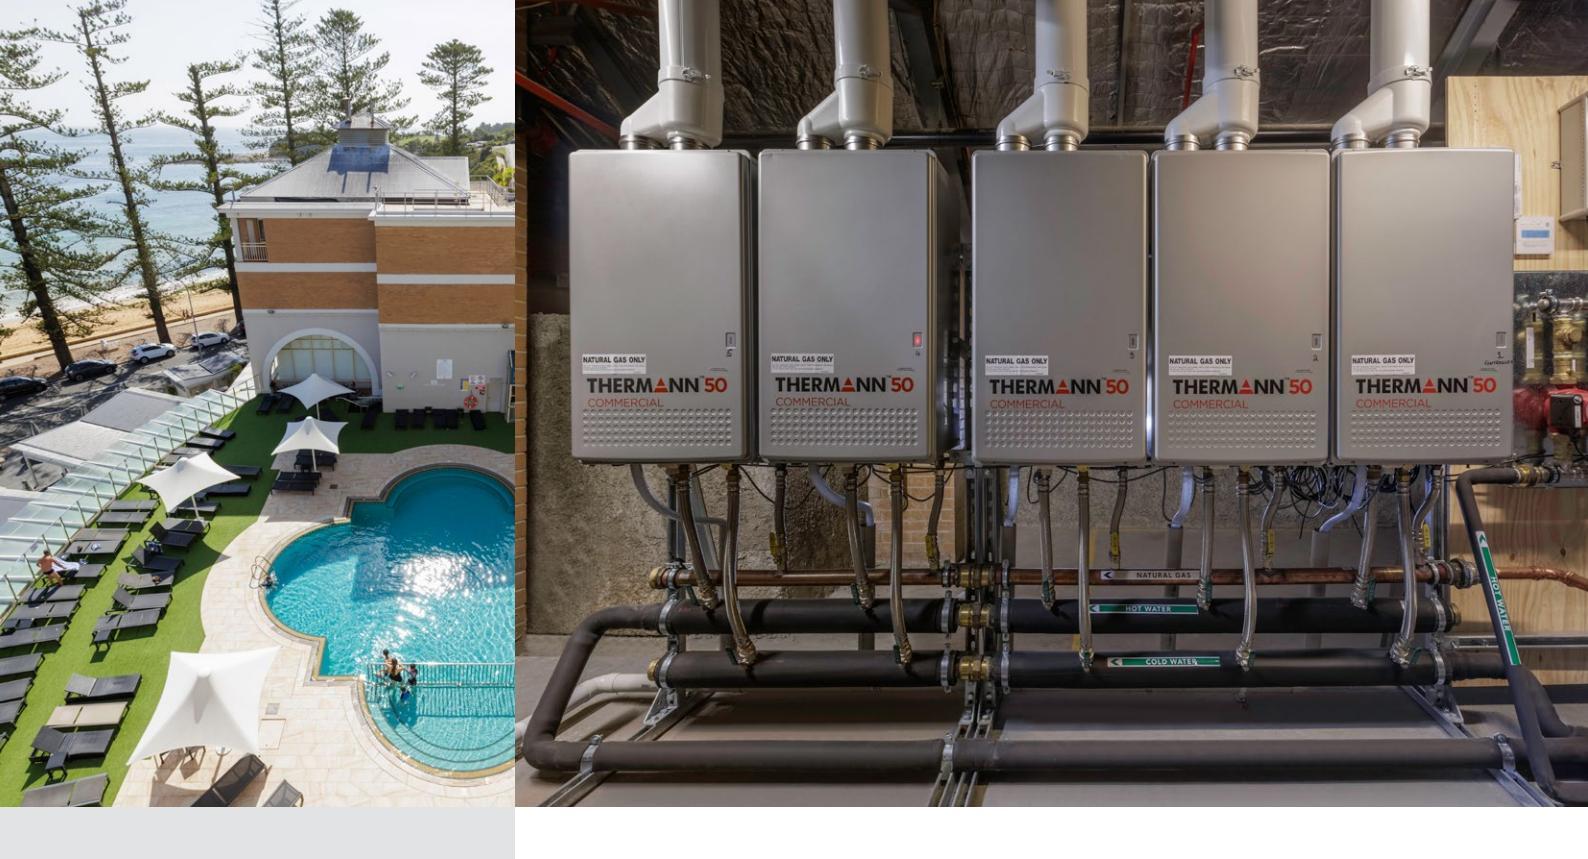
The first system to be upgraded was the main plant comprised of 5 x Thermann Commercial 50L internal condensing continuous flow water heaters. They were manifolded on a frame with integrated dual UPS 32-100 building ring main pumps.

The modular design was an important consideration as the plant room was only accessible by stairs. The new system was partially assembled on site. The biggest component was 1.5m X 1.5m and only 55kg. Assembly of the system was quick and easy. Once the frame was assembled, the water heaters were hung and flexible connections connected.
